Flood Irrigation Tailwater in Jackson County: Summary of Case Studies 2009-2016

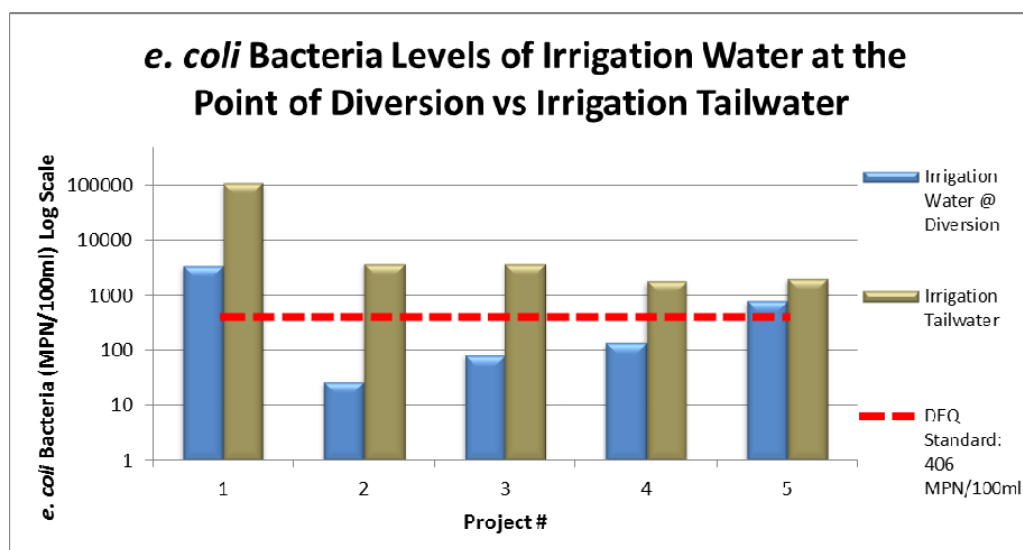
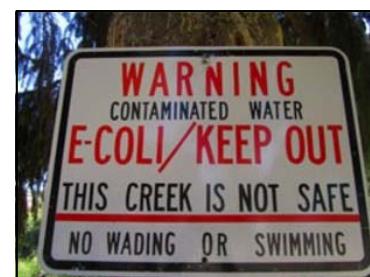
Figure 1: Average *e. coli* bacteria levels were all higher in flood irrigation tailwater than in the irrigation water at the diversion. Water was sampled at various times during irrigation cycles at the diversion and tailwater to quantify how much *e. coli* was contributed to the tailwater by the field. *e. coli* concentrations greater than the DEQ standard means that water is not safe for human contact.

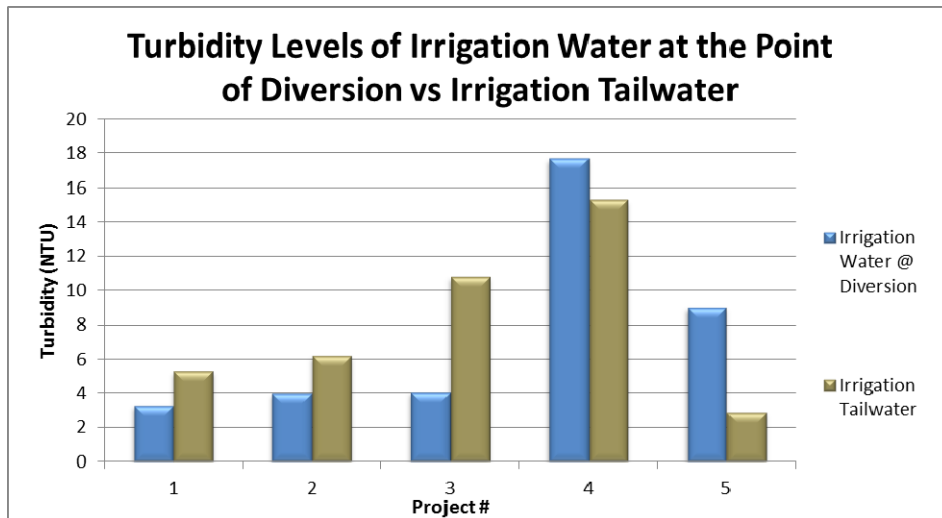
Figure 2: Turbidity is one way to measure the amount of erosion occurring in a field. Each project shows different amounts of erosion or filtering of the irrigation water as it flowed from the diversion to the tail end of the field.

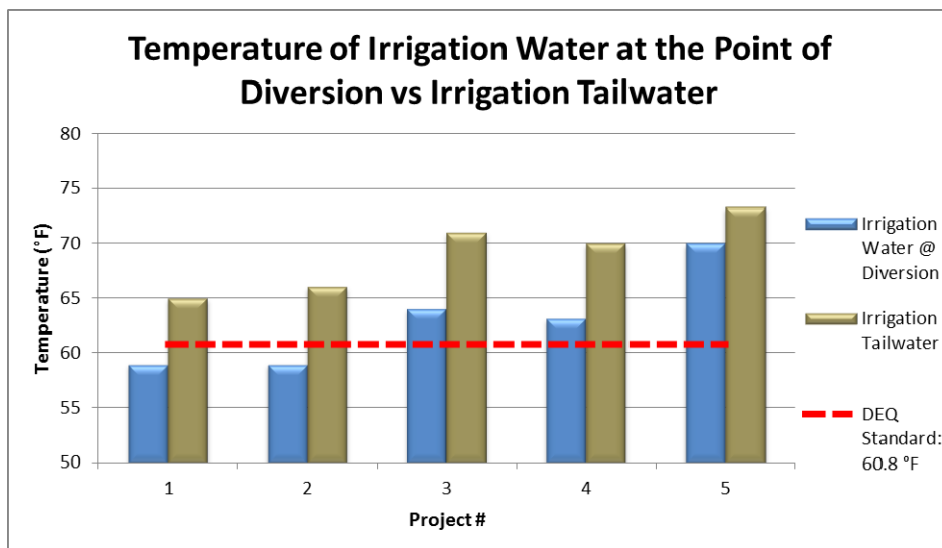
Figure 3: Average water temperature during the irrigation cycle increased in all cases of flood irrigation. Water is heated from the hot dry field, solar radiation, and ambient temperature.

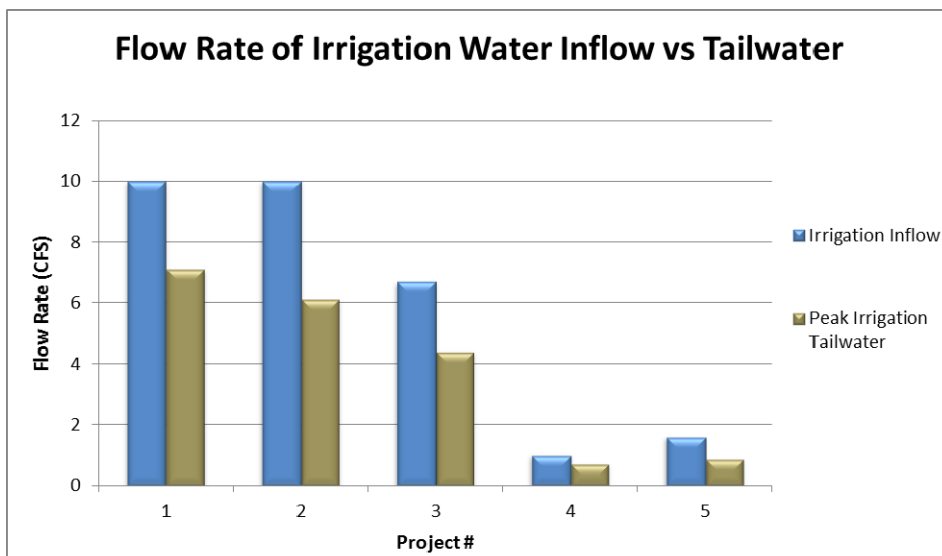
Figure 4: The difference between irrigation inflow and tailwater relates to the irrigation efficiency at that point in time. A substantial amount of flow rate is lost as tailwater off the end of the field and irrigation efficiency tends to be very low.

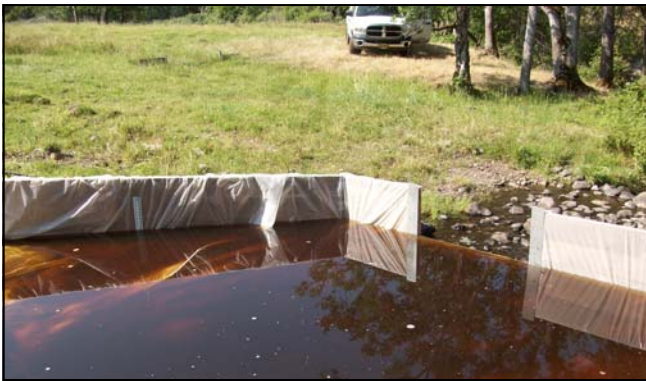
Tailwater measured just before entering creek, Project 2

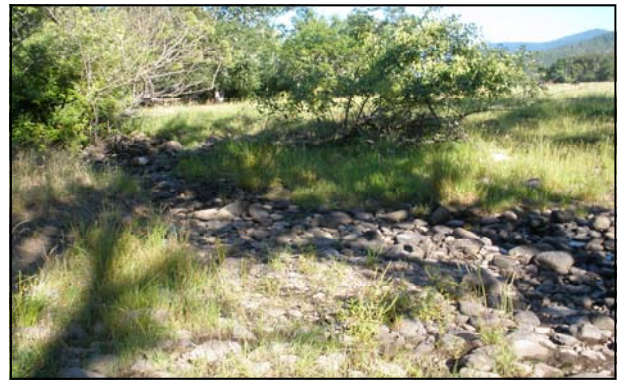
Trace tailwater after Project 2 conversion to sprinkler
